Mitchell River Watershed, Stockroute/reserves Fisheries Audit

T.D. Vallance and A.E. Hogan

**Queensland
Government**
Department of
Primary Industries

MARCH, 2001

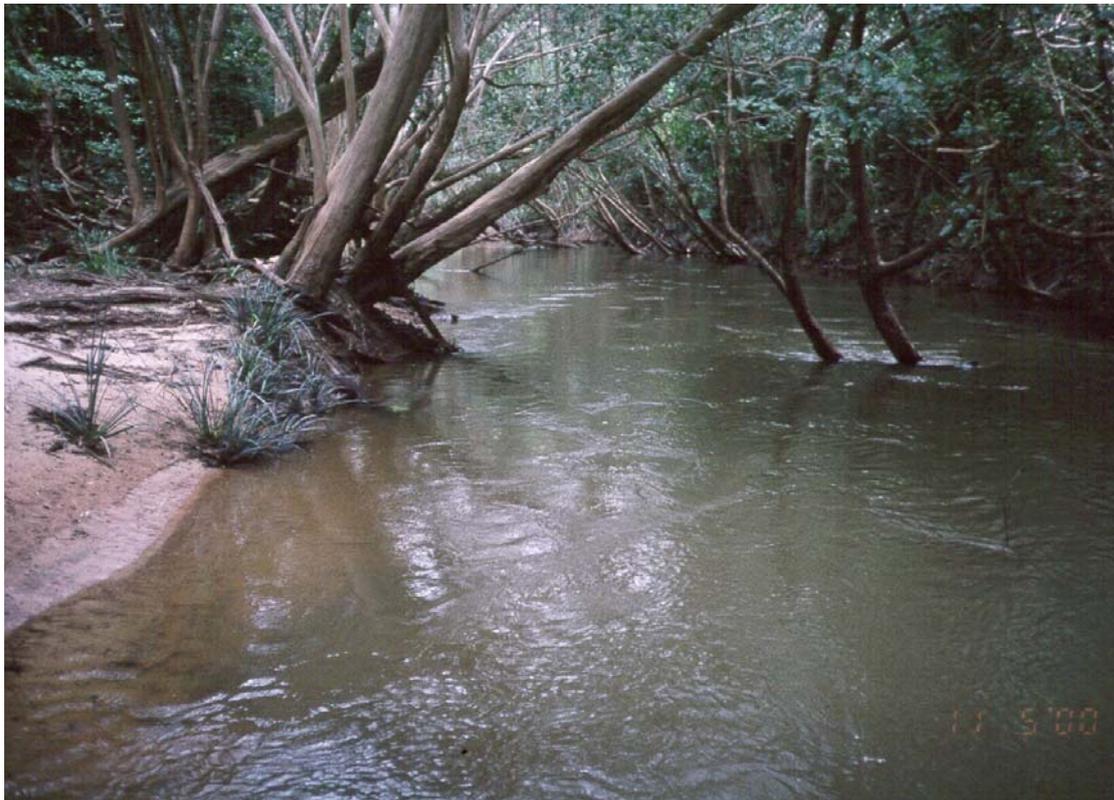
Rifle Creek near the old Weatherby Rd crossing appeared to be in a relatively good condition with riparian vegetation intact and very little disturbance (Figure 2). Water quality was good (Table 1). Fish habitat consisted mostly of logjams and undercut banks. Fourteen species of fish were sampled in this section of river (Table 2). No introduced species were detected.

Figure 2. Rifle Ck at old Weatherby Rd crossing.

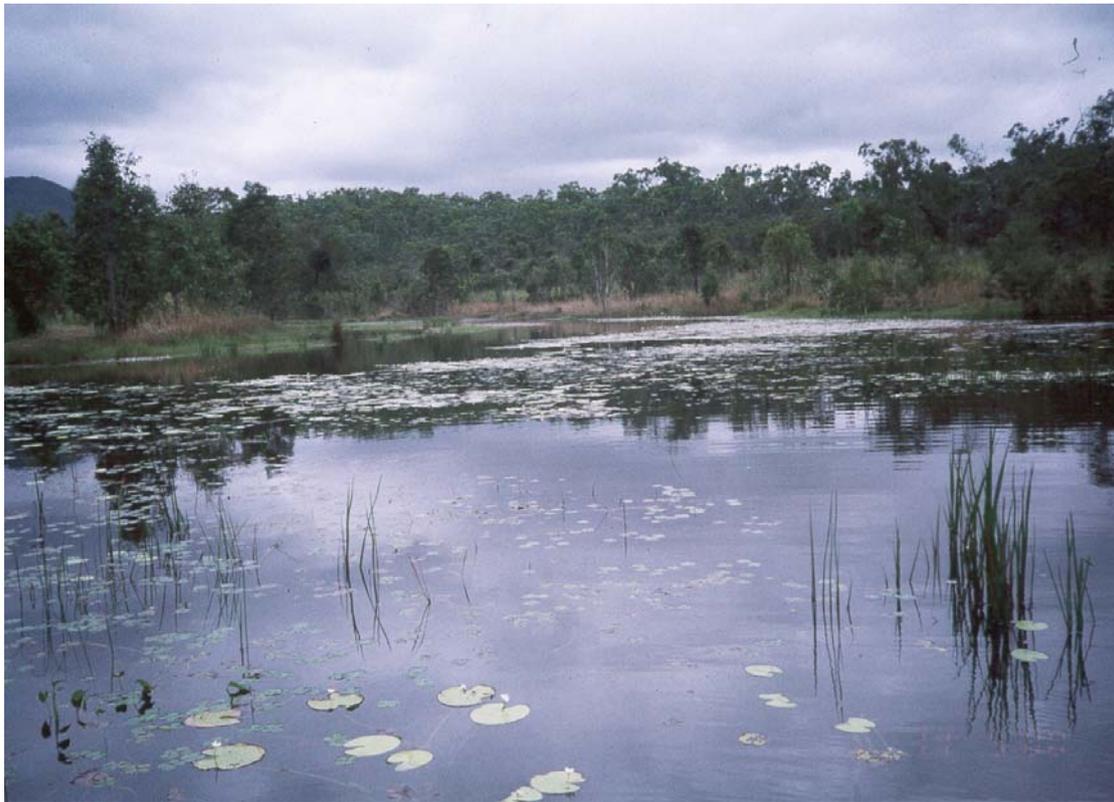
Spear Creek lagoon is an artificially enhanced wetland area on private property. It fills during the wet season when Spear Creek floods overland. Riparian vegetation is sparse with some areas of regrowth. The construction of a dam wall has increased the depth of this lagoon and probably increased its fish habitat values. Fish habitat included extensive weed beds, lily pads and the occasional log (Figure 3). Eight fish species were sampled (Table 3) and water quality was good (Table 1).

Figure 3. Spear Ck. Lagoon.

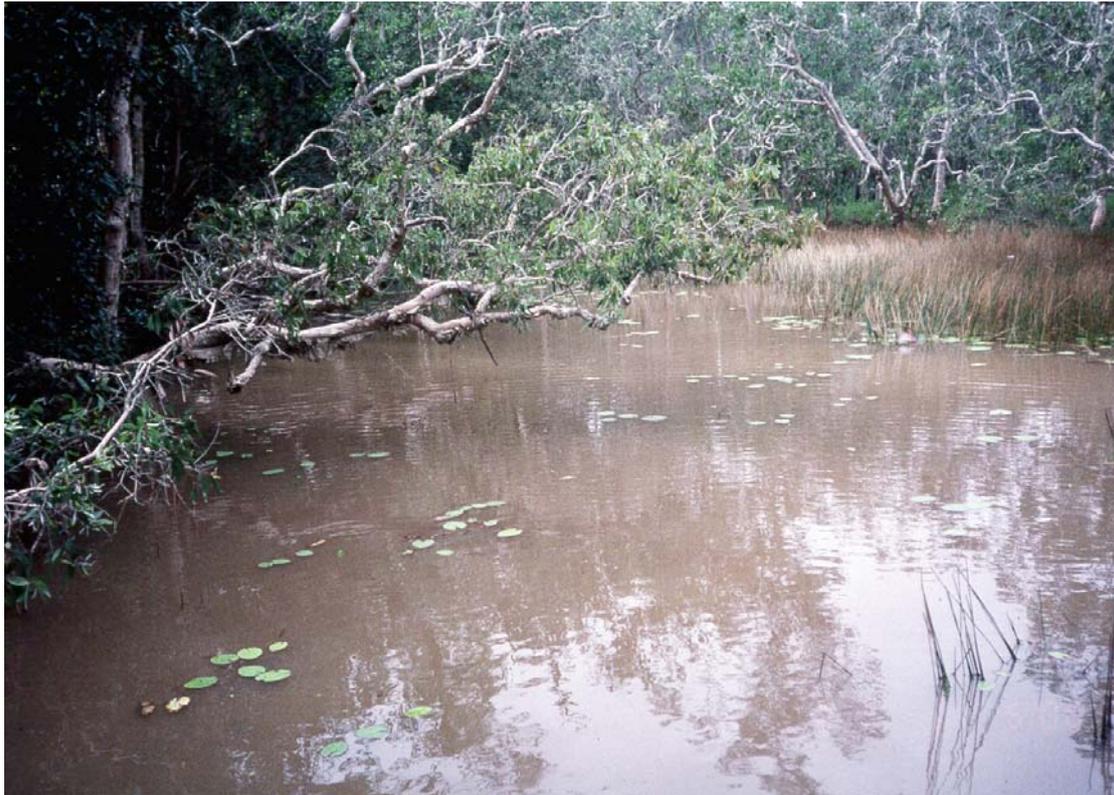
This site was a small lagoon on the roadside not far from Rifle Creek near the old Weatherby Rd crossing (Figure 4). The riparian vegetation was largely intact except for portions near the road where the local council pumps water for roadworks. The water at this site was highly turbid, probably due to runoff from the road. Fish habitat was sparse. There was a lack of weed beds and only one visible log. Dissolved oxygen was low at this site (Table 1) as was fish abundance (Table 4). Only six fish species were recorded at this site.

Figure 4. Roadside lagoon – Rifle Ck.

No unusual or unexpected fish species were detected during this fish survey. Fish populations in the streams and most lagoons appeared to be in good shape. The roadside lagoon (Site 3) had a relatively low fish population and species diversity. This is probably due to the poor water quality at this site, notably oxygen and turbidity. The turbidity may have been caused by runoff from the dirt road nearby and low oxygen due to light being unable to penetrate the water to allow photosynthesis to occur.

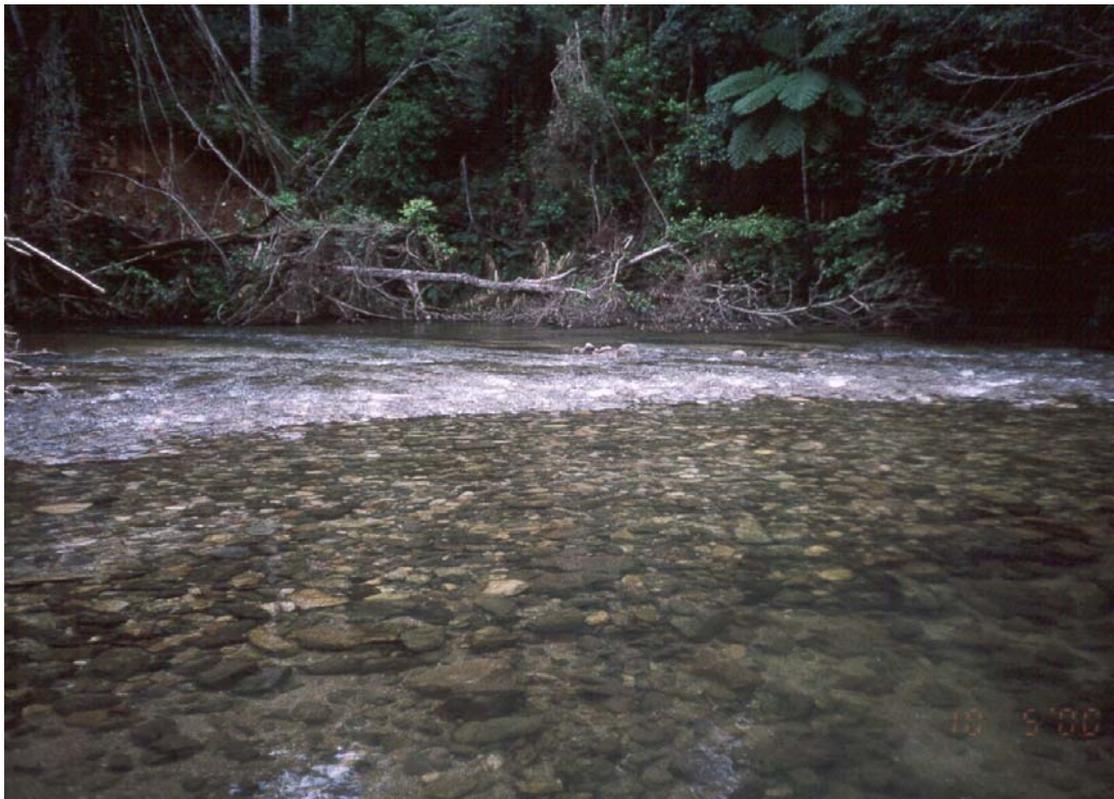
Bushy Creek at the Churchill Creek junction is a relatively pristine rainforest stream. There is very little disturbance upstream of this site. Riparian vegetation was intact and fish habitat was abundant including logjams, undercut banks, sedges, small boulders, and riffles (Figure 5). Water quality was high although water temperature was much cooler than other sites which is common in rainforest streams (Table 1). Nine fish species were sampled at this site which was high considering the size of the stream. Most species were highly abundant and this was the only site where Coal Grunter was sampled (Table 5).

Figure 5. Bushy Ck – top of sample site.

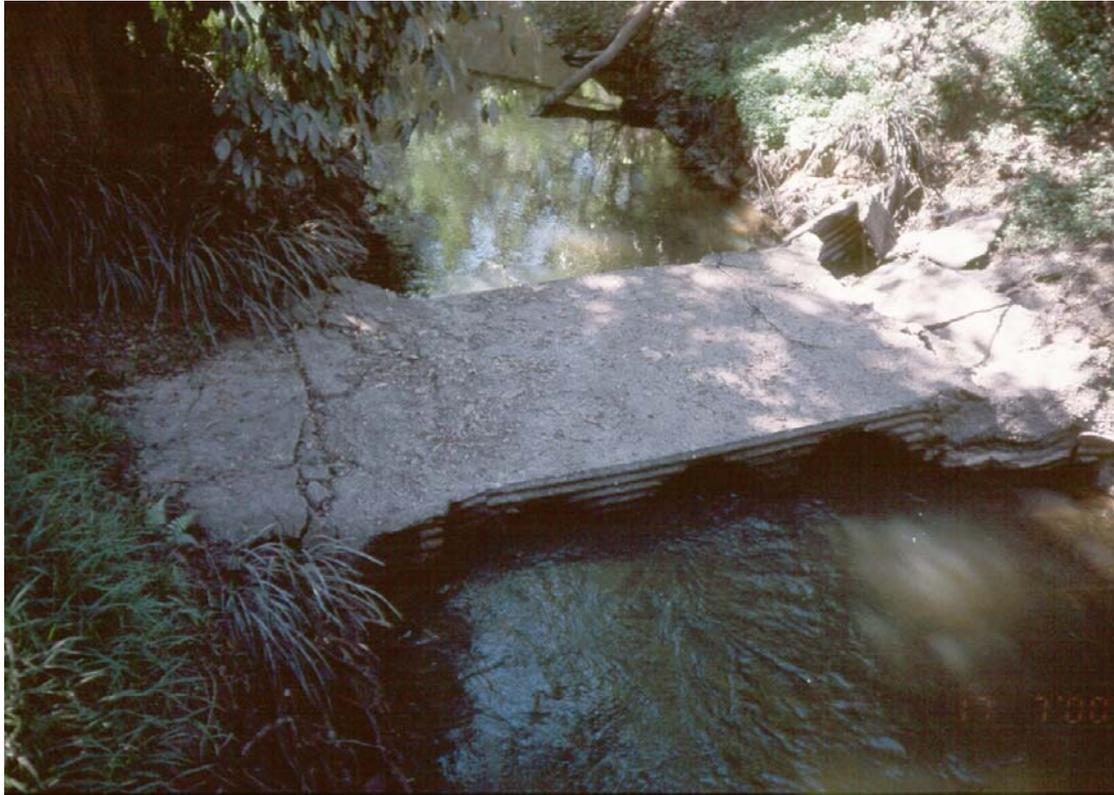
The old culvert crossing at Site 6 is adjacent to the high level bridge. It consists of three pipes covered in concrete and appears to be redundant (Figure 6). During the survey period flows may not have restricted fish movement, however when flow rates increase we suspect that many fish would have trouble negotiating the structure. We suggest that this structure be removed. It would be a relatively simple task with earthmoving equipment and eliminate any potential fish passage issues at this site.

Figure 6. Old culvert crossing, Rifle Ck – M^cLeans Bridge (Site 6).

There are 3 sites where fish passage is impeded at some time throughout the year. We recommend removal of the old culvert crossing on Rifle Ck (M^cLeans Bridge), further investigation of the old highway crossing on Hunters Ck to determine the extent of habitat upstream, and education of local farmers in instances such as the stream works on Rocky Ck (M^cDougall Rd).

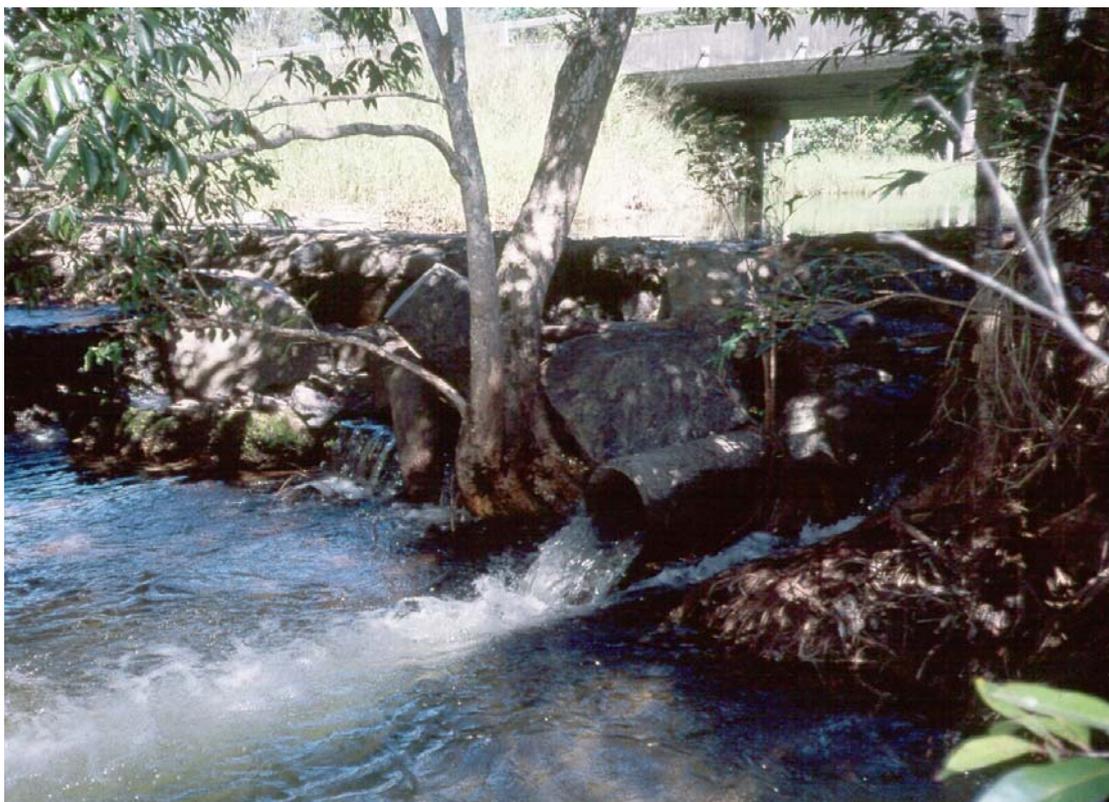
The Hunter's creek road crossing on Rex Range (Site 12) is another site where a new bridge has been constructed and a redundant causeway crossing left in place. This crossing is approximately 1.5 metres above the downstream river level and during low flows all water diverts through a small pipe (Figure 7). We believe fish would be unable to negotiate this instream structure even during flood flows due to the large drop and turbulence created. Further investigations into the extent of upstream habitat are required before making any recommendations for improving fish passage. The cost of repairing this site may outweigh any benefits gained.

Figure 7. Old causeway, Hunter's Ck – Rex Range Rd (Site 12).

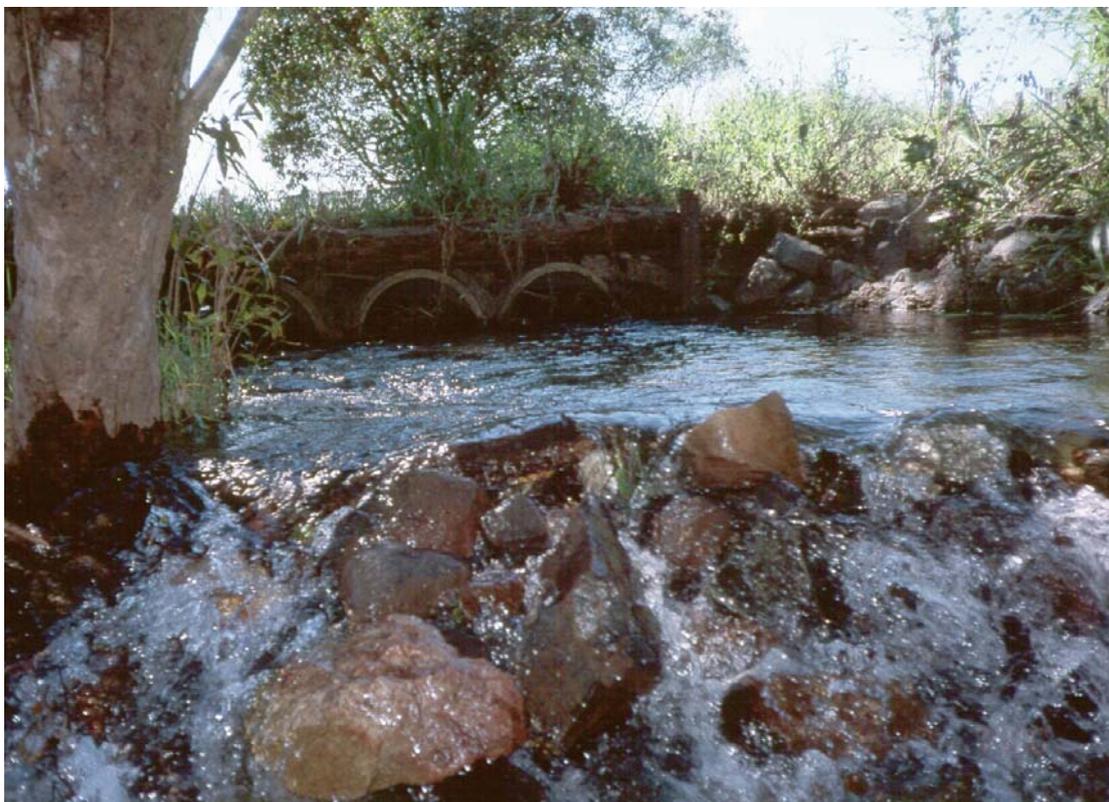
Figure 8. Small rock wall at Rocky Ck, M^cDougall Rd (Site 10).

Site 10 is flooded completely during high flows and may not cause any problems for fish passage at this time. However, to create a pool for pumping water some stream diversion has taken place upstream of the road crossing and a small rock wall approximately 0.7 metres high has been constructed downstream (Figure 8). This would inhibit fish passage during low flows but is likely to burst and/or drown out during flooding. Education of local farmers of potential fish passage problems with such structures and providing them with advice to improve the situation may be the best course of action.
